Influence of Chemical Corrosive Environment with H₂S on Drill Strings, Experimental Researches

Abstract: The present researches established the failure causes of the drill string, used in corrosive environments with H₂S, in an oil field, by initiating fatigue cracks from the corrosion points on the inner surface of the drill pipes, which favoured the diffusion of hydrogen, the brittleness of the material and the brittle fracture.

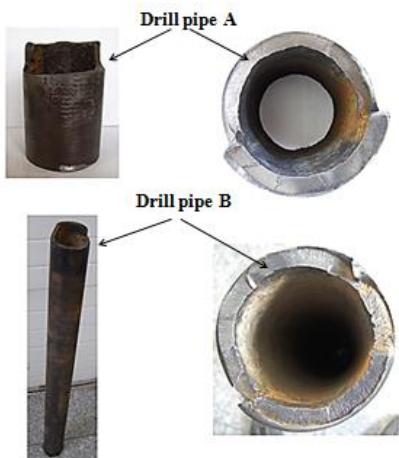
Figure 1. Fractured drill pipes

The fracture occurred in the body of the drill pipes, in the cylindrical area. On the outer surface of both drill pipes were visible fingerprints from the gripping and rotating devices used for make-up/break out connection. The fingerprints can be cracks source for fatigue failure.

For both drill pipes, on the fractured surfaces, two distinct zones were highlighted: a relatively flat area, extended on approx. 3/4 of the cross-sectional area of the drill pipe, having a perpendicular orientation on the axis of the drill pipe, which represents the main fracture surface, and a fracture zone unevenly compared to the fracture plane, with the height of approx. 20 mm (for drill pipe A), respectively approx. 30 mm (for drill pipe B), which represents the final fracture zone (Figure 1, Figure 2).

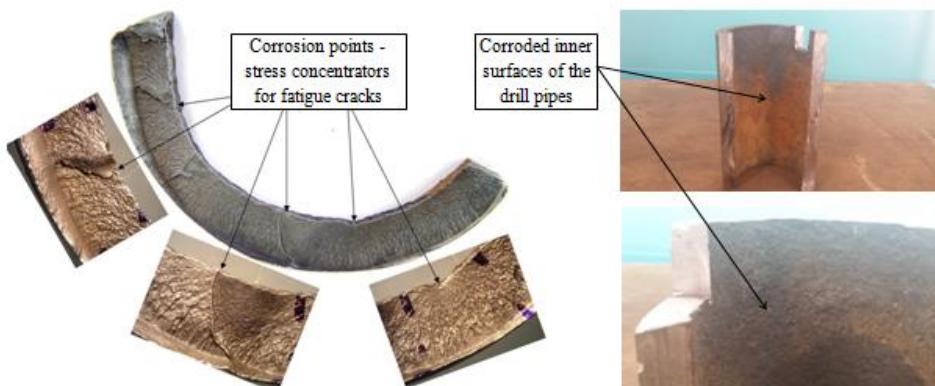
The fracture surface of the drill pipes present a typical morphological aspects of a fatigue fracture surface, caused by the nucleation/initiation and propagation of cracks under cyclic loading. The fatigue cracks were initiated and developed from the corrosion points on the inner surface of the drill pipe, strongly corroded, as shown in Figure 3. The corrosion points, with depths up to 1 mm, represent stress

concentrators that initiate the fatigue cracks. The fatigue cracks, starting from the corroded inner surface, were propagated through the thickness of the drill pipe towards the external surface.

Figure 3. Fatigue cracks initiation from the corrosion points

It can be appreciated, after the macroscopic analysis, that the fracture of the drill pipes occurred by initiating fatigue cracks from the corrosion points on the inner surface of the drill pipes. These corrosion points represent stress concentrators that favored the diffusion of hydrogen at the peak of the concentrator, the brittleness of the material and the brittle fracture. The effect of hydrogen sulfide was manifested in two aspects:

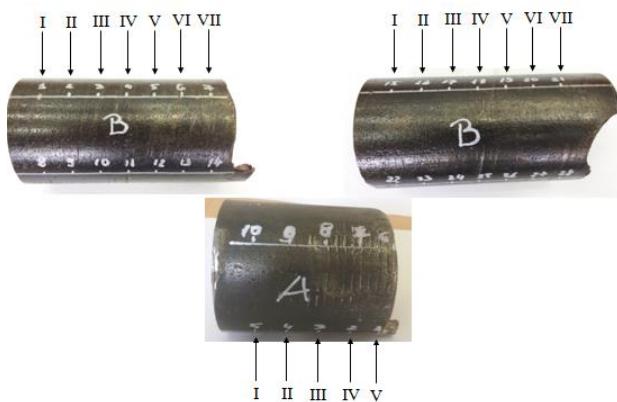
Figure 5. Planes and points marked for outer diameter and wall thickness measurements

The outer diameters measured are smaller than the minimum standardized diameter for drill pipes (tolerance to the standardized outer diameter is ± 0.79 mm). The wall thickness measured is within the tolerance provided by the standard (12.5% of the standardized wall thickness).

There were no significant differences between the values of wall thicknesses, which show a uniform corrosion inside the drill pipes.

Measurement of outer diameter of the analyzed drill pipes have shown the fact that in the fractured area the diameter is constant, indicating a fracture without plastic deformation of the drill pipe, having another cause than the tensile overstress of the drill pipes. For comparison, in Figure 6 is presented, from specialized literature, the aspect of the fracture for two drill pipes subjected to tensile stress by exceeded the yield strength of the material (overload), where the plastic deformation of the fractured area is highlighted, having a specific fracture aspect cone-cup.

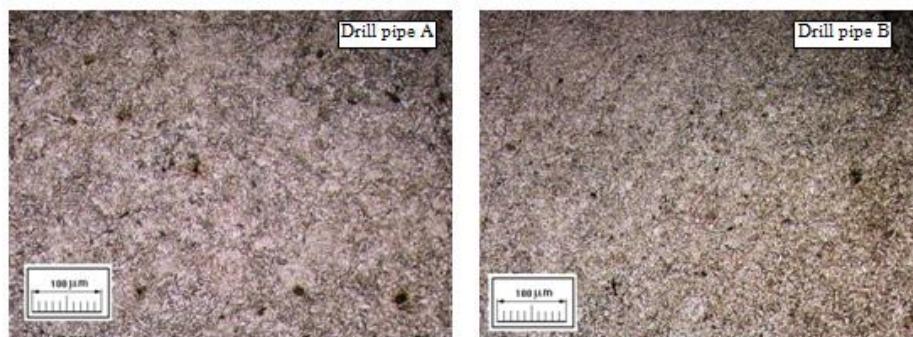
The metallographic analysis performed by optical microscope revealed that the structures consist of tempered sorbite (Figure 7), corresponding to the application of a quenching and tempering heat treatment.

Figure 7. Metallographic structures of the fractured drill pipes' material

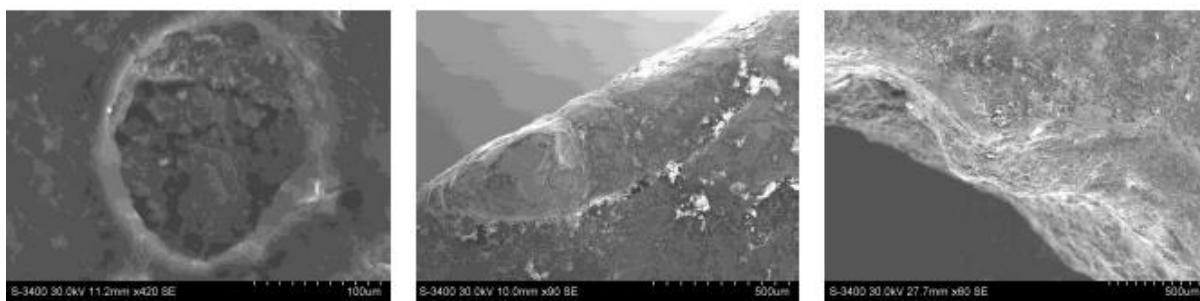
The metallographic analysis performed by the scanning electron microscope (SEM) revealed a brittle fracture with possible areas of hydrogen accumulation (Figure 8).

Figure 8. The electron microscope appearance of the fractured surface of drill pipe A (the craters observed on the fractured surface correspond to possible hydrogen accumulations)

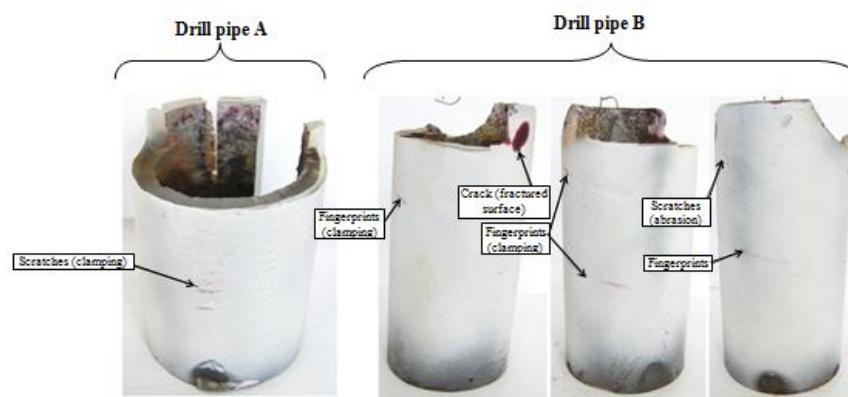
The liquid penetrant non-destructive testing performed onto the fractured drill pipes (Figure 9) aimed to determine their surface's defects. On the surface of the drill pipe A, there were visible deep scratches due to the clamping in the gripping device but, no cracks were observed. In contrast, on the surface of drill pipe B there was observed a crack propagated from the fractured surface, fingerprints due to clamping in the gripping device, deep scratches of abrasive wear, without no other cracks detected.

Figure 9. Liquid penetrant non-destructive testing
