# Factors Involved in Stress Corrosion Cracking of Tubes from a Nuclear Power Plant Feedwater Heater

*This study has been carried out to identify the operating factors involved in the failure of two tubes made of 304 stainless steel removed from a high pressure feedwater heater working in a nuclear power plant. The samples cut from tubes have been analyzed by different methods: visual examination, optical (metallographic) microscopy, scanning electron microscopy, and energy dispersive X-ray spectroscopy. Following analyses, on the surface of tubes was highlighted the presence of many pits in which cracks have started. Inside the pits, impurities of the type S, Cl, K, Ca were detected too. The branched cracks most likely have occurred as a result of precipitation of small amounts of chlorides deposited and concentrated on the surface of the tubes over a long period of operation. The stresses that favored this type of corrosion cracking were both residual stresses and stresses occurring at the torsion and bending of the tubes, while the high water temperature from feed heater was also a favorable factor for corrosion. The final conclusion was that the tubes failed by a chloride indu

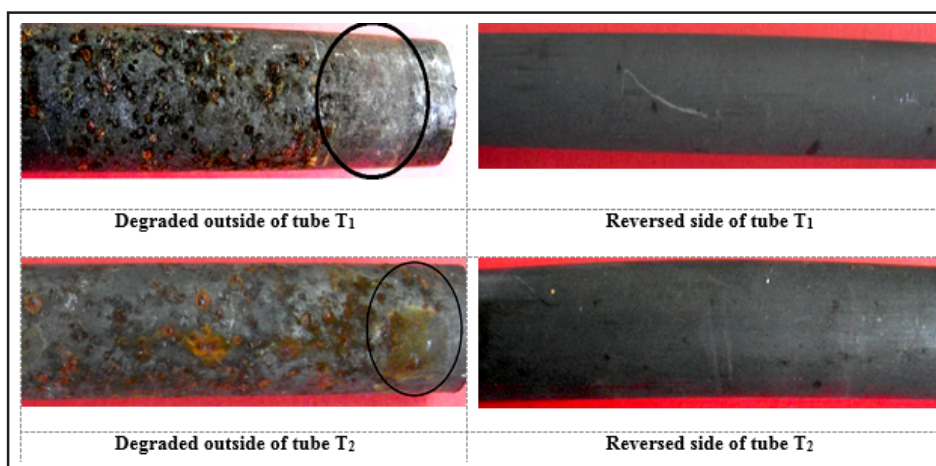
Using the visual inspection made on the entire length of both tubes ( $T_1$  and  $T_2$ ) it has been noticed that on the tube surface there were marks resulted from friction with the tubes supports and also scratches probably from manipulation at removing (Figure 1). Moreover, on the one side of both tubes red oxides and hard deposits have been observed, formed over a black oxide (magnetite), while on the reverse side there is a magnetite layer maintained almost intact (Figure 1). These mean that the faces of tubes were degraded being subjected to small droplets of water which eroded tubes. On the reverse sides, just dry steam was in contact with the tubes, therefore it may be the aggressive agent. For an easier manipulation in the further analyses after visual examination, the tubes have been cut in pieces of 2 cm of length. By metallographic analysis of the tubes at a low magnification ( $\times 40$ ) the corrosion products have been observed, covering the most

Fig. 1. Optical microscopy aspect of  $T_1$  and  $T_2$  tubes surfaces

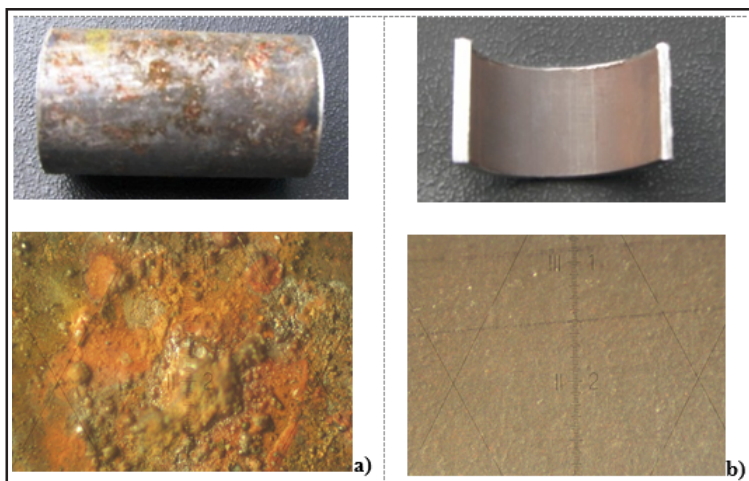
outside surface while on the inside, only an adherent oxide layer was detected (Figure 2).

Fig. 2 (a) Red oxides and hard corrosion deposits visualized on outside surface and (b) an adherent oxide layer on the inside surface (magnification  $\times 40$ )

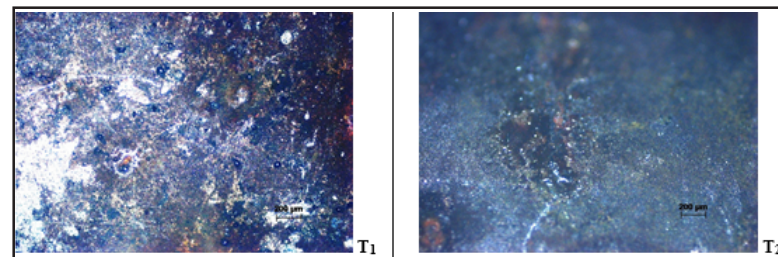
For the following analysis, the surfaces of samples were brushed to remove the hard deposits. After brushing the oxides, there were observed on the entire surface of tubes pits with different sizes (Figure 3). This means that, under the corrosion products layer, the impurities from water have been concentrated and in time these can lead to pitting corrosion. After complete removing of oxides using an acidic aqueous solution (15%  $\text{HNO}_3$ , 3%  $\text{HF}$ , 3%  $\text{HCl}$ ) for 30 seconds at temperature of 75 °C, on the samples surface have been relieved many pits and longitudinal cracks, as in Figure 4.

Fig. 3. Outside surfaces after oxides brushing (magnification  $\times 50$ )

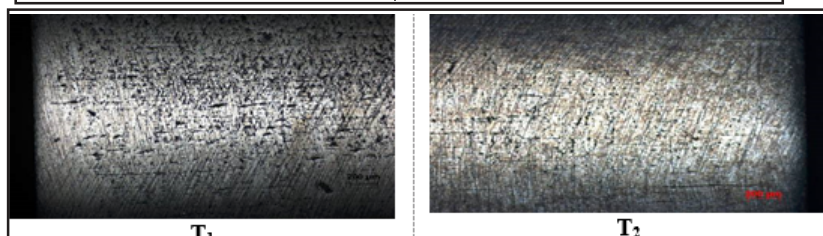
Fig. 4. Pits and longitudinal cracks on the tubes surfaces after descaling ( $\times 50$ )

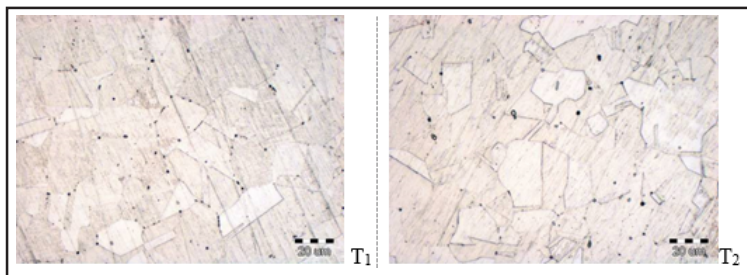
Fig. 5. Austenitic microstructure of T<sub>1</sub> and T<sub>2</sub> samples (x500)

characteristic to 304 stainless steel (Figure 5). There are not visible carbides at grain boundaries but many inclusions can be observed, formed probably in casting process of the steel. The SEM analysis of the tubes surfaces also revealed the presence of a black oxide film (magnetite) over which there are distributed needle shaped crystals (Figure 6). Another SEM images, achieved into pits filled with oxides, highlighted the presence of the same needle shaped crystals (Figure 7). The chemical composition of the oxides formed on the outside surface was determined from the EDS spectrum obtained by analysis in points on the tubes surface. This elemental analysis revealed that the oxides contain iron, chromium, nickel, oxygen and

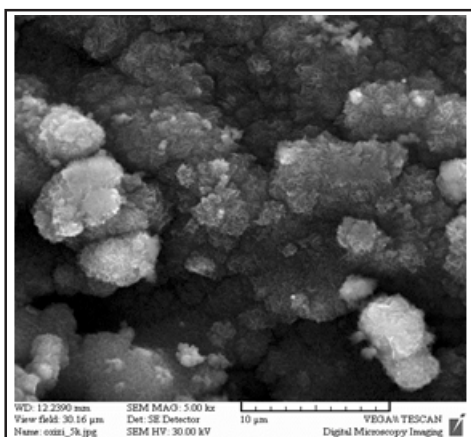
Fig. 6. SEM image of outer oxide layer with needle shape crystals inclusions (x5000)

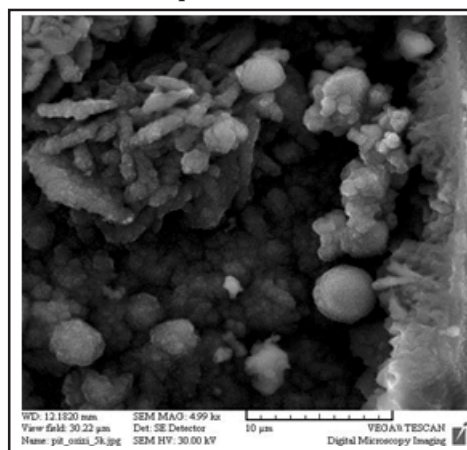
Fig. 7. SEM image of the needle shape crystals inside of pits (x5000)

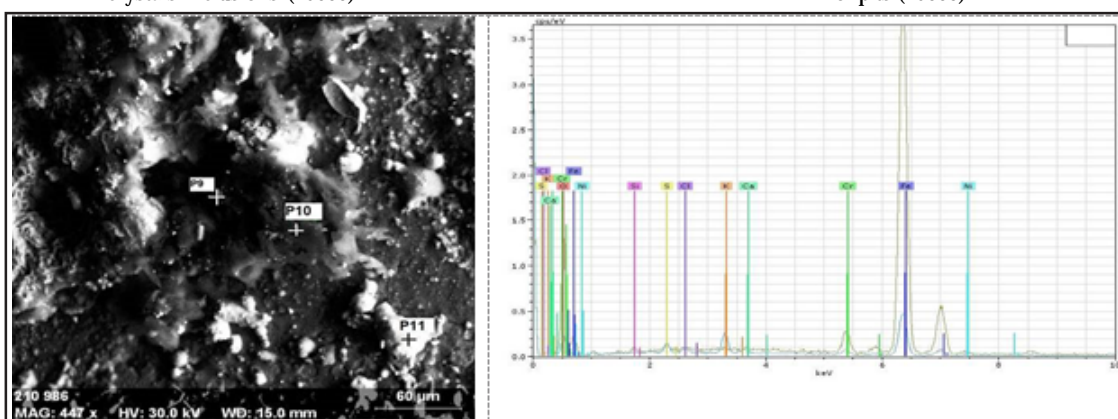
some impurities, such as chlorine, sulfur, calcium, and potassium (Figure 8). Table 1 shows that the concentration of impurities in examined points is quite high. Accordingly, a conclusion may be that the needle shaped crystals detected by SEM are crystals of chlorides (CaCl<sub>2</sub> or KCl). Detection of these impurities demonstrates that inside of the preheater the unpurified water remains stationary, thus allowing accumulation and concentration of salt impurities on the hot surfaces of the tubes. The unpurified water can come from a damaged condenser which usually is cooled with raw water. The supposition that the impurities from steam could reach up to the base metal can be supported

Fig. 8. EDS analysis in points showing the presence of impurities (Cl, Ca, S, K) in oxides (P10,P11) and inside of pit (P9)

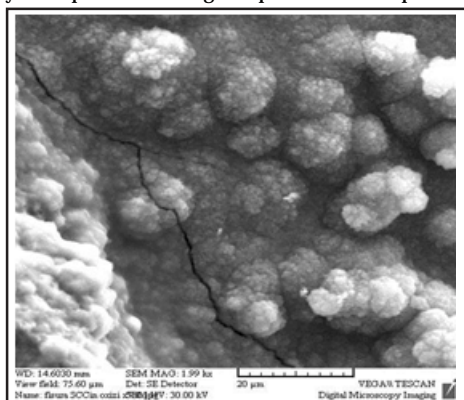
Fig. 9. SEM image of the cracks in the oxide (x2000)

by the SEM analysis which revealed long cracks in the oxide layer that can be penetration paths for impurities (Figure 9).

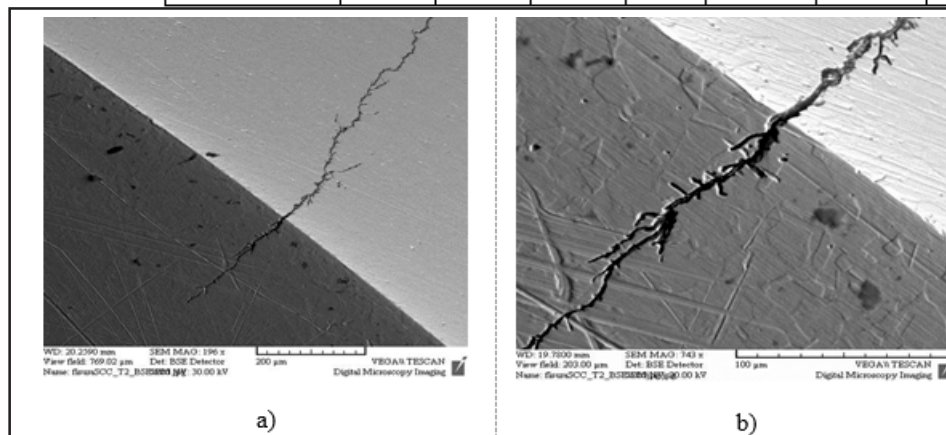
Fig. 10. Secondary electron SEM image of longitudinal crack identified on the tube's surface a) (x200), b) (x700)

In the next step of analysis, a transverse cross section through the longitudinal cracks has been performed. Figure 10 shows secondary electrons SEM image of one longitudinal crack which was also identified previously through optical microscopy on the outside surface of tube T<sub>2</sub>. Note that the crack is branched, and passes both at grain boundary and through the grains. The crack has been initiated from a surface pit and propagated in the longitudinal direction and to the inside, close to half of wall thickness. This type of branched crack usually occurs on 304 stainless steel when chlorides are present in operating water [5]. The chlorides were detected by SEM/EDS on the surface of tubes analyzed, so the conclusion is that tube degradation can be related to chloride stress corrosion cracking (CSCC).

The cracks most likely occurred as a result of very small amounts of chlorides deposited and concentrated on the surface of the tubes over a long period of operation. Chlorides salts are coming from the condenser which probably has some problems at the tubes and allows the raw water (used for cooling) to arrive as condense into the high pressure feedwater heater. Degradation by corrosion as a result of the relatively high steam velocities (high flow rate of steam) in this area where the tube wall temperature is cycled. Generally, when a unit ramps down, the tubes remain relatively hot, drying the outside of tubes after they have been again in a wet condensing area. This drying, then wetting and also drying cycle, will tend to concentrate minors amounts of impurities (as chlorides) on the tube's surface [5].

- identification of any leaks from condensers to avoid entry of aggressive environment;
- a rigorous chemical control of environment to prevent local concentration of aggressive species in the areas with restricted circulation;
- regularly inspections of tubes, especially in problem areas, as in the cooler drain, near the inlet of steam around plugging tubes and random;
- residual stress elimination by heat treatments applied to tubes before use;
- a rigorous control of tubes surfaces before the installation for elimination of the surface defects.
