# Multianalytical Study for Establishing the Historical Contexts of the Church of the Holy Archangels from Cicau, Alba County, Romania, for its Promotion as a World Heritage Good

## I. Assessing the preservation-restoration works from the 18<sup>th</sup> century

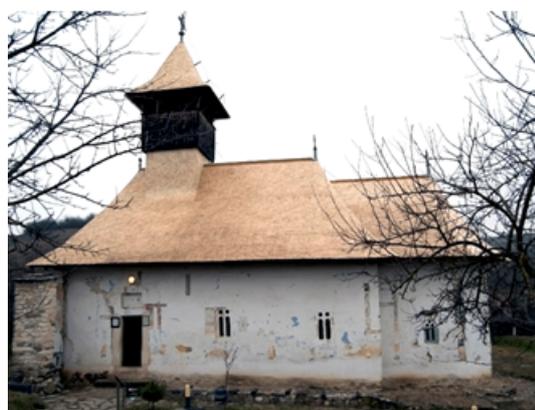
Fig. 1. General view from the South of the Church of the Holy Archangels from Cicau, Alba County

The Church of the Holy Archangels in Cicau, Miraslau commune (fig. 1) was, according to the known data [19], built in 1495, with significant transformations after 1710. The interior painting, which has survived in the Altar and the Naos, is particularly valuable but in a relatively poor state of conservation (fig. 2). From the stratigraphic point of view (by means of coring), three layers of fresco are found, dating from the 18<sup>th</sup> century, the 15<sup>th</sup> century and, respectively, a much older one, from the 11<sup>th</sup>-12<sup>th</sup> century. Part of the 18<sup>th</sup> century fresco from the esonarthex (inner narthex; Rmn. *pronaos*) is found under several overlapping layers of whitewash. These aspects became noticeable during the photofixation, collecting pictorial/masonry materials, and various calorimetry measurements through reflexion and reflectography (fig. 3).

From the architectural point of view, the church is currently comprised of a roofed esonarthex, superimposed by the bell tower (fig. 1), the nave (Rmn. *naos*) and the altar, with a hemicylindrical vault and polygonal recessed apse, which are covered by an ellipsoid vault (fig. 2). Initially, according to the available historiographical and archaeological data, the church was composed of nave

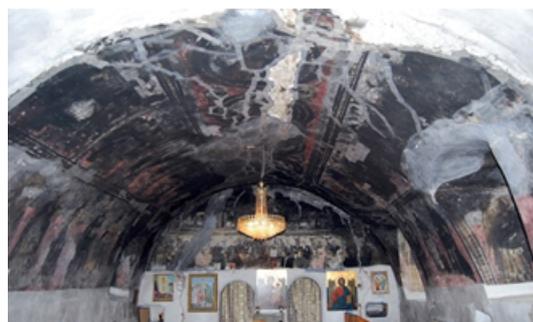
Fig. 2. The fresco from the nave (1495)

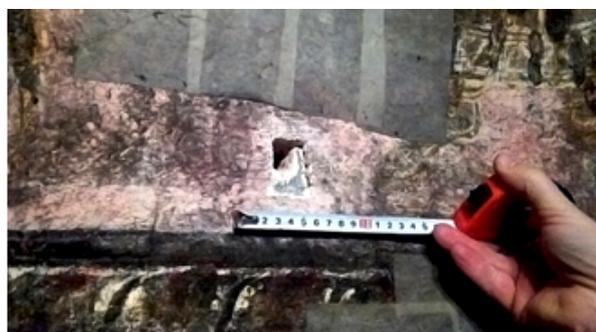
Fig. 3. Stratigraphic view of the two fresco through the coring

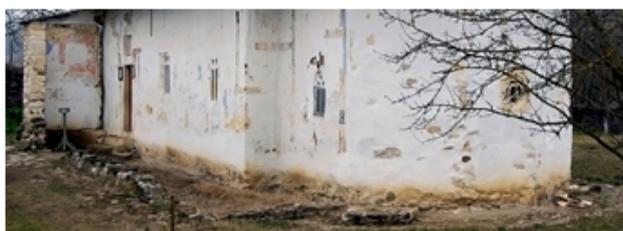
Fig. 4. The entry door and the remains of the exonarthex from 1775-1780

and the altar, divided by an altar screen made of a single large stone slab, possibly from a sandstone concretion with an adequate planimetry and thickness, brought from the stone quarry located a few meters away. The altar screen has only two entries (the royal door on the right, and the deacon's door on the left) carved into the rock (fig. 2). After 1700, the old nave was extended westwards, with the present-day esonarthex, and the western wall demolished, while the old stone frame of the initial entry was moved to the southern side of the new esonarthex, where a new exonarthex was built [19]. Currently, only the western wall and the external foundation from the South and East have been preserved (fig. 4).

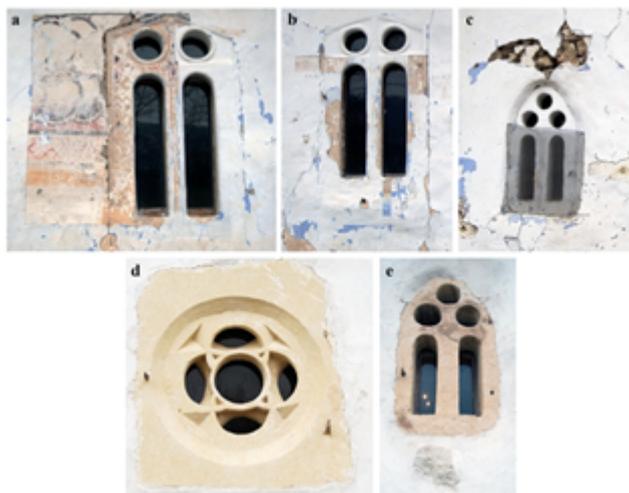
Fig. 5. Details with the five windows from the old part of the church: a-c. from the nave and esonarthex (South); d. from the altar (East); e. from the nave (North)

The church has six windows, five of which found in the older part. The windows are lobe-shaped, of Gothic style, with stone frames embellished by carving and chiselling (fig. 5a). The window on the eastern side of the altar is round (Fig. 5b), with tracery, four-lobbed in shape, while the other four are mullioned (fig. 5c-e), with a semicircular closing at the top, and three round holes above [19].

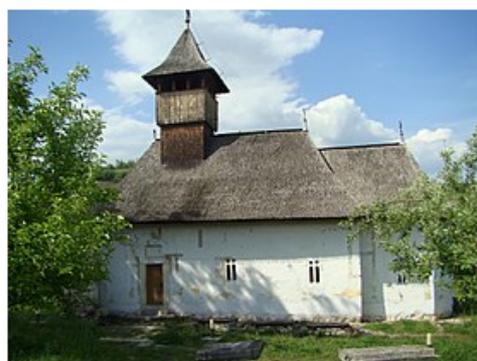
Fig. 6. Overall image from the South of the Church of the Holy Archangels from Cicau, before the 1995-1998 restoration works. Photo source: Tetcu Mircea Rares, 2009 [23]

Presently, after the interventions at the foundations and the roof, followed by improving through restoration the western wall, originating from the stone frame of the entry on the southern side of the last esonarthex and of the foundations left on the southern and eastern sides, the church entered the tourist circuit (fig. 6).

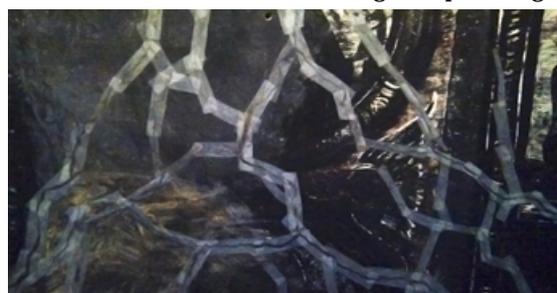
Fig. 7. Detail of the adhesive tape applied over the dynamic cracks in order to stop the deterioration of the interior frescoes

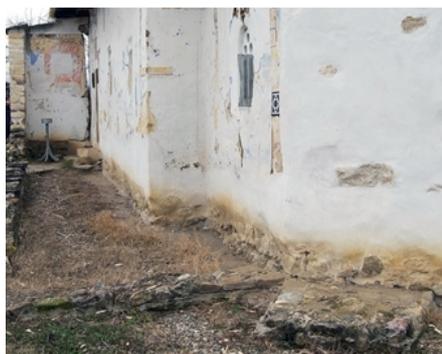
Fig. 8. Improper preservation-restoration interventions

This church is a notorious example of improper restoration interventions, for which the norms of the Code of Ethics of the Conservation Science for historical monuments, unanimously accepted worldwide [24]. The interventions affected the overall image of the monument, both at the inside and outside. They were due to the lack of financial resources and qualified and certified personnel; instead, the workers applied nonconforming adhesive tape over the dynamic cracks in order to stop the deterioration of the interior frescoes (fig. 7), rebuilt the western wall of the exonarthex using ornate stone from other part of the old nave, and failed to consolidate the fissure from the joint with the main segment of the church; then, they applied a layer of whitewash over the exterior fresco, and did not restore the exposed foundation (fig. 8).

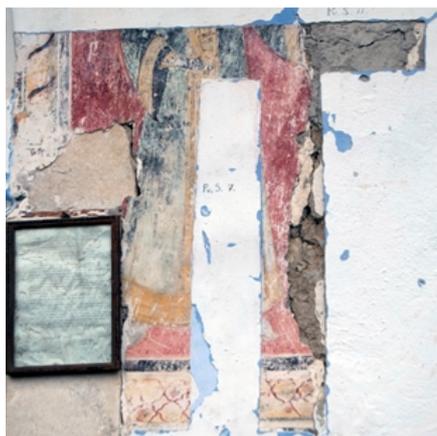
Fig. 9. Improper interventions for consolidating and preserving the reference marker areas

Likewise incorrectly finished were the consolidation works for some of the masonry elements, the cleared area kept as markers, and others (fig. 9).

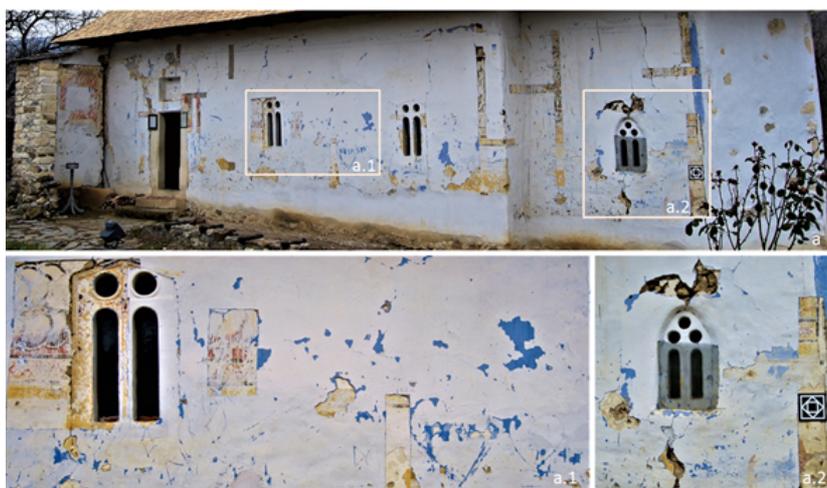
Fig. 10. The Church of the Holy Archangels (1495) from Cicau: a.1. and a.2. Details with inadequate interventions and signs of vandalism [25]

Exemplifying this situation, we can observe in figure 10 the advanced state of degradation of the southern and eastern facades. The images clearly show at least four rows of whitewash over the original painting. Also

observable are the written graffiti (vandalism) through which people marked their presence in the church or their feelings for others by scratching or engraving heart shapes and other markings on the wall [25].

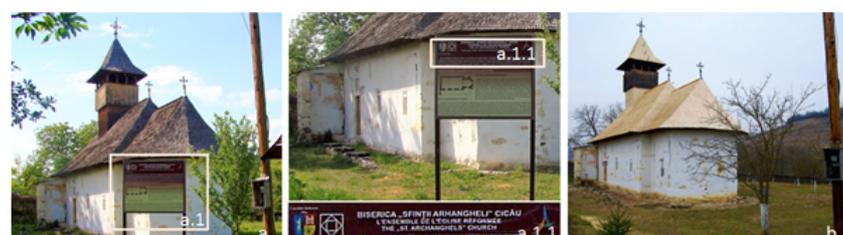
Fig. 11. The Church of the Holy Archangels (1495) from Cicau; a, a.1 and a.1.1. Details with the presence of the indicator [25, 26]; b. overall image without the indicator from during the period when the samples were collected

version claimed that the church was Reformed, as can be seen in Figure 11, without further clarification, such as the period and the reason. Even though this indicator has since disappeared, there still remains the question how were the panels approved in the first place?

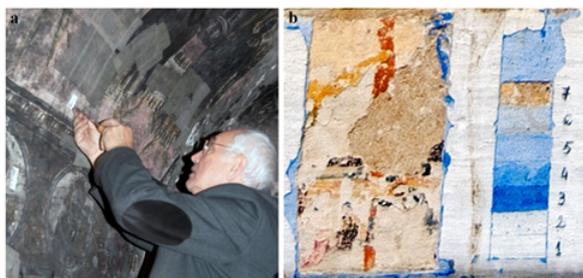
Fig. 12. Areas for collecting pictorial material samples: a. from the interior frescoes; b. from the overlapping whitewash layers covering the exterior fresco

Figure 12 presents the areas from where samples were collected of the pictorial material of the interior frescoes and of the overlapping whitewash layers over the exterior fresco.

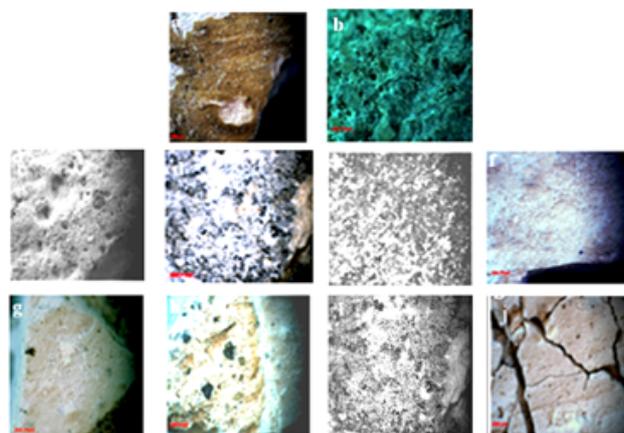
Fig. 13. OM microphotographic images (5×) of the colour samples from the exterior fresco and the eight samples from the whitewash layers covering the exterior fresco: a. ochre; b. green; c. L1; d. L2; e. L3; f. L4; g. L5; h. L6; i. L7; j. L8

Figure 13 presents the OM microphotographic images at a 5× magnification of the two samples of colour (ochre and green) from the exterior fresco and of the eight whitewash samples from the layers covering the exterior fresco (L1-V8). We notice the degradation of these samples from processes of oxidative fouling and chromatic shift through acido-basic and redox processes.

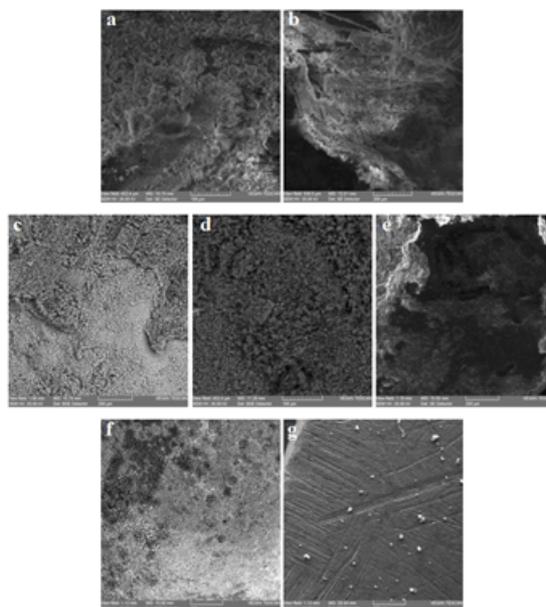
Fig. 14. SEM microphotographs of the two colour samples (ochre and green) from the exterior fresco and a selection of five representative samples from the eight collected from the whitewash layers covering the exterior fresco: a. ochre; b. green; c. L1; d. L2; e. L3; f. L4; g. L5

Figure 14 presents the SEM microphotographs, and Table 1 the data of elemental analysis assessed from the EDX spectra of the two colour samples (ochre and green) from the exterior fresco and the eight whitewash samples covering it (in these experiments, the samples L4, L5 and L6 were dropped because they had very similar characteristics with samples L1, L2 and L3; henceforth, sample L7 becomes L4, and sample L8 becomes L5).

The data in table 1 show that the process of carbonation represented by the concentration in carbon, calcium and oxygen is an edifying archaeometric characteristic, with the whitewash layers being applied in the L1–L5 order. With respect to the moments when the whitewash layers were applied, starting from 1781, the year the exterior fresco was painted, by involving the chemometric characteristics  $\Delta C\% = C_{(t+1)} - C_{(t)}$ , we can approximate the following dates: the first whitewash layer was applied ca. 6–8 years ( $\Delta C\% = 0$ ), ~1792; the second layer after 18–20 years ( $\Delta C\% = 1.181$ ), ~1812; the third after another ca. 48–50 years ( $\Delta C\% = 0.397$ ), ~1862; the fourth after ca. 50–55 years ( $\Delta C\% = 0.042$ ), ~1912; and the fifth after another ca. 60–65 years ( $\Delta C\% = 0.038$ ), ~1977. This is a good fitting for a period of 220 years.

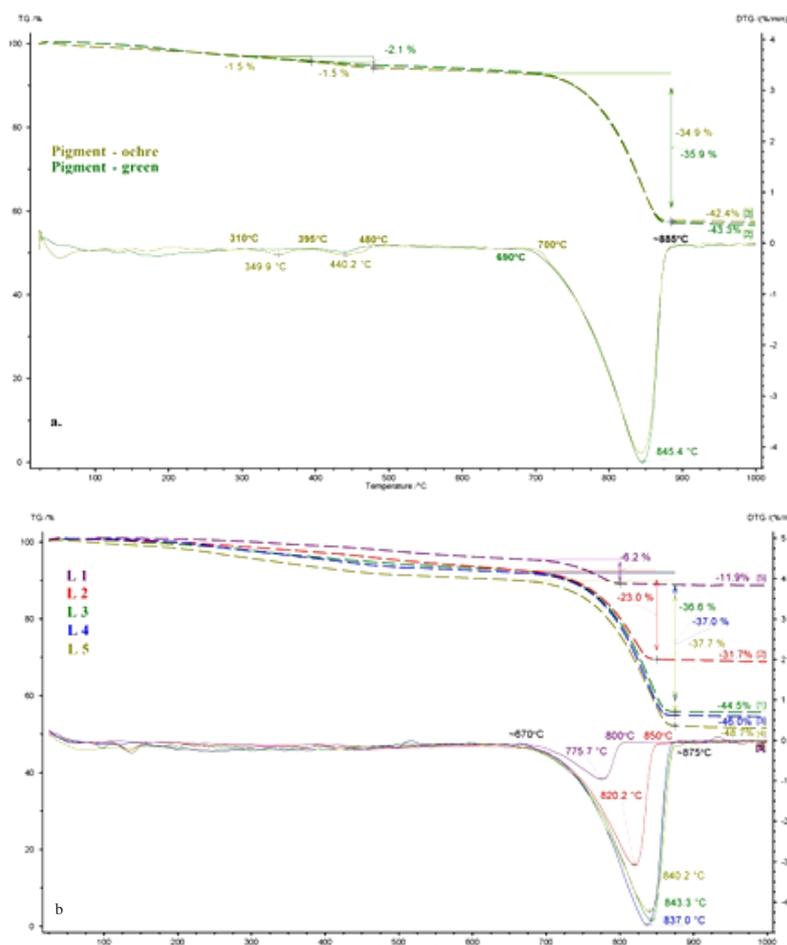
Fig. 15. Evolution of the two important characteristics (TG-% and DTG-%/min) for the pigment (a) and whitewash (b) samples

On the basis of the derivatograms of the two groups of samples—two pigments from the exterior fresco (ochre and green), which are representative for this period, and, respectively, five samples of whitewash from the layers covering the exterior fresco—, using a processing software (Proteus), we ascertained the evolution of the two important characteristics (TG-% and DTG-%/min), on the basis of which we assessed the archaeometric characteristics for thermal behaviour in dynamic conditions at a speed of 12°C/min, presented in figure 15.

The two pigments, representative for the exterior fresco from the chronological timespan under scrutiny, displayed similar thermal behaviour. A main process can be observed between ~690–700°C and ~885°C, with a maximum speed at ~845°C and a mass loss of ~35%. Between ~310°C and ~480°C, another process with mass loss occurs, which presents two stages for the ochre layer (with a maximum speed at ~350°C and ~440°C), while for the green layer it appears only in the stage from ~395–480°C. The green layer is more thermally stable at heating under ~500°C (1% less mass loss than the ochre layer), but becomes slightly unstable at greater temperatures, with an ~1%

greater loss of mass in the main decomposition process, and commencing  $\sim 10^\circ\text{C}$  earlier compared with ochre layer. The final mass loss at  $1000^\circ\text{C}$  is  $\sim 43\%$ ,  $\sim 1\%$  more for the green layer. These behaviours, very close for the two pigments originating from coloured earth, demonstrates that they have the same age since execution.

Conversely, the five whitewash samples from the structures overlapping the exterior fresco, heated to  $\sim 500\text{--}600^\circ\text{C}$  present a gradual and continuous loss of mass of  $\sim 4\text{--}10\%$ , without displaying clear DTG peaks. Temperatures over  $\sim 670^\circ\text{C}$  trigger a more rapid process of mass loss, which ends at  $\sim 800\text{--}875^\circ\text{C}$ . Even though all samples start to lose mass faster at approximately the same temperature ( $\sim 670^\circ\text{C}$ ), the process unfolds differently for each of the whitewash types analysed. Samples L5 and L4 have the temperature of the maximum speed of the process ( $\sim 776^\circ\text{C}$  and, respectively,  $\sim 820^\circ\text{C}$ ) and the temperature of the end of the process ( $\sim 800^\circ\text{C}$  and, respectively,  $\sim 850^\circ\text{C}$ ) significantly lower than the other samples ( $T_{\text{max}} \sim 840^\circ\text{C}$ ,  $T_{\text{fin}} \sim 875^\circ\text{C}$ ). The thermal stability of the samples decreases in the order  $L1 > L2 > L3 > L4$

$> L5$ , with the degradation initiated at  $\sim 670^\circ\text{C}$  generating a process that unfolds in a wider temperature range and with a loss of mass greater as the thermal stability decreases. The small deviations in the evolution of these samples can be explained by the nature, calcination technology and provenance of the limestone used for producing the whitewash.

The archaeometric characteristics (the threshold for mass losses and the temperature domain specific to these losses) of the two pigment samples from figure 10a are almost identical (differences of ca.  $\sim 1\%$ ), which demonstrates that the execution took place simultaneously.

Conversely, for the whitewash samples, these characteristics present three strongly differentiated thresholds, which correspond to the periods the respective whitewash layers were applied, very differentiated in time: for sample L5 (the outer layer) of ca. 40 years ago, then sample L4 of 105 years ago, while samples L3, L2 and L1 were applied in a period between 155 and 225 years ago.
