# Retrieving Broken Metallic Instruments from Root Canal by Using the Ultrasound System and Endodontic Microscope

*During root canal instrumentation several accidents may occur, one of them being the separation of the instrument. The chemical structure of metallic broken instrument has an important role in the therapeutic approach. Due to metal fatigue, over instrumentation, incorrect speed, bad technique, and several other reasons, the endodontic instruments, manual or rotative, may break inside the root canal. The broken piece usually gets stuck inside the dentine walls. Several years ago, such accident was equal to the loss of the tooth, but nowadays, with the use of the endodontic microscope and ultrasonic tips, the teeth can be fully restored as the separated instrument can be removed safely.*

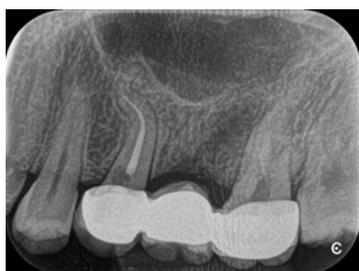
Tulsa Dental) and the ledge created initially was by-passed using pre-curved K-Files no 06, 08 until we reached the working length confirmed by apex locator (fig. 4). Root canal shaping was performed using ProTaper Next system, X1, X2 Ni-Ti and cleaning using NaOH 5%, EDTA, saline solution and CHX 2%. Root canal filling was performed using warm vertical condensation of gutta-percha and sealer. Root canal treatment was completed by aligning the coronal access cavity using light curing composite resin and post-operative radiography (fig. 5).

Fig. 4 Removal of the broken file

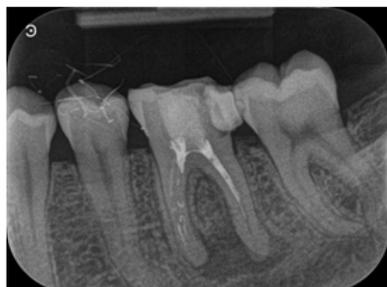
Diagnosis: Asymptomatic chronic apical periodontitis with previously initiated root canal treatment. Broken file on the distal root canal of 46. (fig. 6)

Fig. 6. Preoperative x-ray of 1<sup>st</sup> molar - Asymptomatic chronic apical periodontitis

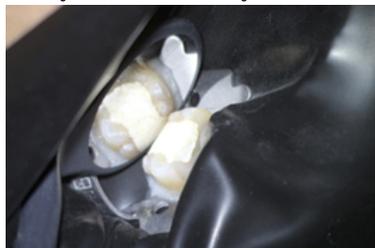
Fig. 7. Isolation with rubber-dam

After isolation with rubber dam (fig. 7) the old coronal filling was removed and the access cavity was completed according to known principles with the reconstruction of the distal wall with glass ionomer cement (fig. 8). The old gutta-percha was removed from the root canals using rotary Ni-Ti files (D System D1, D2, D3 ProTaper Dentsply

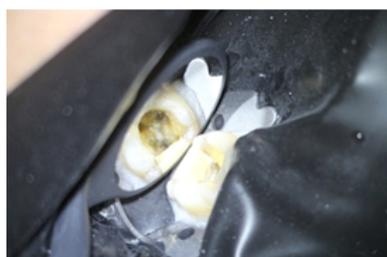
Fig. 8. Removal of the filling and preparation of the access cavity

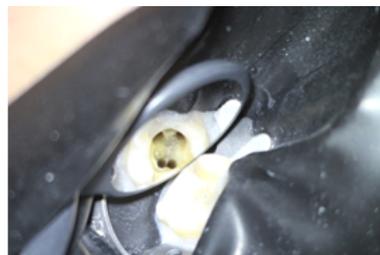
Fig. 9. Pre-flaring and enlargement of the canals

Maillefer) and Eucalypt oil as a solvent under heavy irrigation with NaOH 5% (fig. 9). The ability to access and remove the broken file on the distal root canal in the middle third of the root is influenced by the cross-sectional diameter, length and curvature of the root, therefore is very important to visualize and expose at least one third of the overall length of the obstructing instrument.

We used Gates Glidden burs in order to create sufficient space in the coronal third of the root canal, with a brushing technique, and each larger GC is stepped out of the canal to create a smooth flowing funnel that is largest coronally and tapers down to the head of the broken instrument.

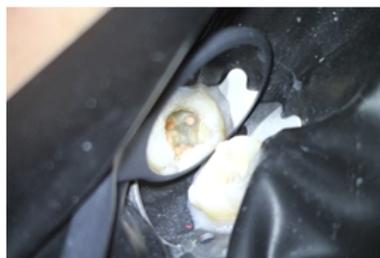
Fig. 10. Root canal filling- warm vertical condensation of gutta-percha and sealer

Under magnification we used ultrasonic techniques together with abrasively-coated ultrasonic tips (ProUltra Endo Tips no 3, 4, 5, Dentsply Tulsa Dental). The final filling was done using warm gutta-percha (fig. 10) and we verified it in a post-operative radiography (fig.11).

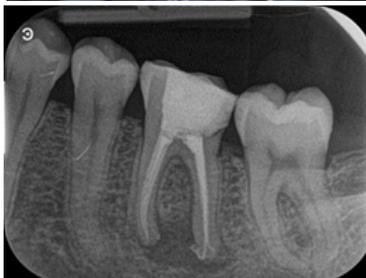
Fig. 11. Post-operative radiography

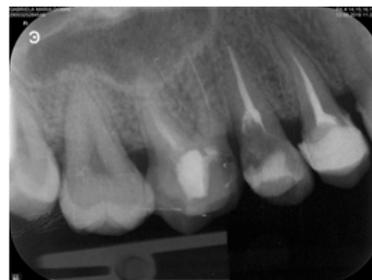
Diagnosis: Asymptomatic chronic apical periodontitis with previously initiated root canal treatment tooth 1.6. Broken file on the mesio-buccal root canal (fig.12).

Fig. 12. Pre operative radiography

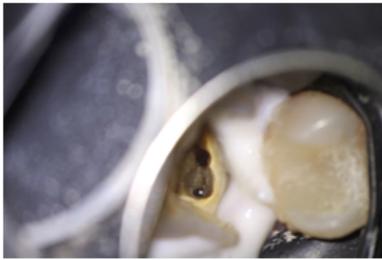
Fig. 13. Rubber dam isolation

After isolation with rubber dam the old coronal filling was removed and the access cavity was completed according to known principles with the reconstruction of the mesial wall with glass ionomer cement. The old gutta-percha was removed from the root canals using rotary Ni-Ti files (D System D1, D2, D3 ProTaper Dentsply Maillefer) and Eucalypt oil as a solvent under heavy irrigation with NaOH 5% using ultrasonic activation. (fig.13) We identified

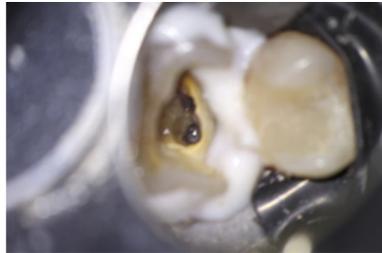
Fig. 14. The broken file on the mesio-buccal root canal

the broken file and we removed it using the ultrasonic tips (fig. 14). After removal of the old root canal filling material we identified the second mesio-buccal root canal and they were all shaped using the Pro-Taper Next system with NaOH 5% irrigation under magnification and ultrasonic activation. Root canal filling was performed using warm vertical condensation of gutta-percha and sealer (fig. 15). Root canal treatment was completed by sealing the coronal access cavity using light curing composite resin and post-operative radiography (fig.16).

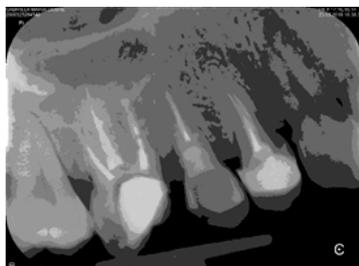
Fig. 16. Post operative radiography

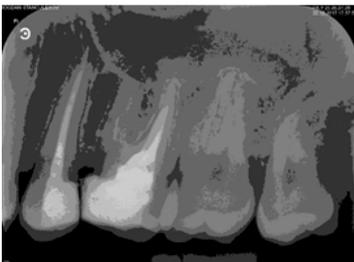
Diagnosis. Symptomatic chronic apical periodontitis with previously initiated root canal treatment tooth 2.6. Broken file on the mesio-buccal root canal (fig. 17, 18).

Fig. 17. Pre operative radiography

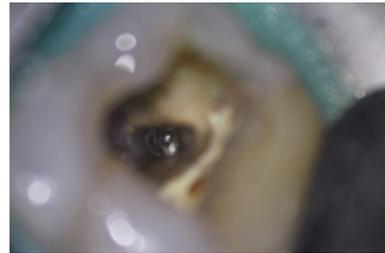
Fig.19. Removal of the broken file

We followed the same therapeutic protocol in cleaning and shaping but the root canal filling was performed on a second appointment due to persistence of leakage in the canals and severe pain on 2.6 on vertical percussion. After the removal of the broken file on the mesio-buccal canal (fig. 19) the shaping and cleaning was performed using the Pro-Taper Next system using NaOH 5% and ultrasonic activation. For the temporary root canal filling we used a paste with calcium hydroxide for 14 days. After that period of time the tooth was pain free so we removed the calcium hydroxide paste using citric acid 10% and the root canal filling was performed using warm vertical condensation of gutta-percha and sealer (fig. 20) Root canal treatment was completed by sealing the coronal access cavity using light curing composite resin and post-operative radiography (fig. 21).

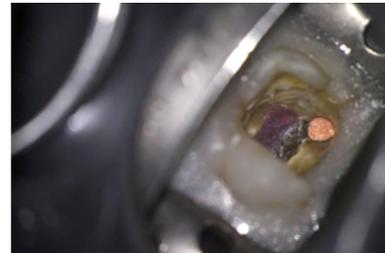
Fig. 20. Root canal filling

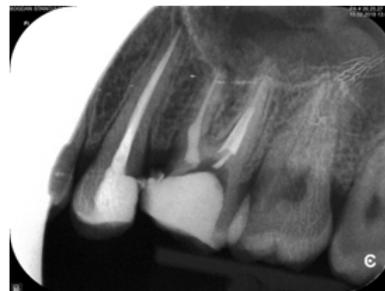
Fig.21. Post operative radiography
