# Cavitation Erosion Resistance of Laser Beam Nitride Layers of X5CrNi18-10 Stainless Steel

ILARE BORDEASU<sup>1\*</sup>, CORNELIA LAURA SALCIANU<sup>1\*</sup>, MIRCEA OCTAVIAN POPOVICIU<sup>2</sup>, ION MITELEA<sup>1</sup>

<sup>1</sup> Politehnica University of Timisoara, 1 Mihai Viteazul Blvd., 300222, Timisoara, Romania

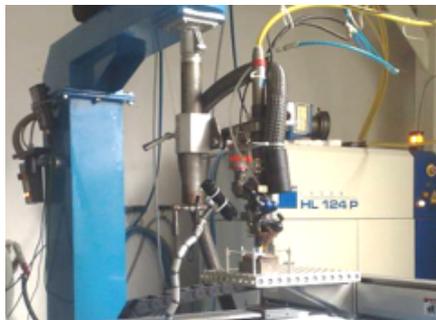
Fig. 1. HL 124P LCU device

and more common because is very easy to be applied and in the same time it realize good functioning layers without substantially influencing the basic material [12, 14, 15]. This advantage is given by the nitration with a transversal speed of about 100 mm/s [12], achieving a strong dissolution of nitrogen and so forming a hard layer. For the nitration of cavitation erosion samples was used the Trumpf HL 124 P LCU device equipped with programmable pulsed laser Nd-YAG, (fig.1), found in the endowment of

the Timisoara National Institute for Researches in the Field of Welding and Material Testing.

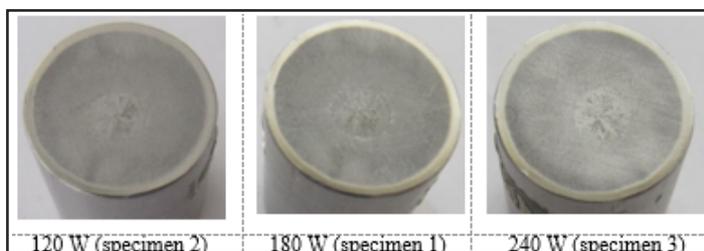
Fig. 9. Images of the eroded nitrated layer after 165 min of exposure to cavitation

- the reduced scatter of the experimental values (after minute 45), around the mediation curves are the result of the uniform distribution of the hardness in the entire area of the nitrated surface, as a result of the accuracy of the nitration procedure respecting the working parameters (impulse power, speed of beam movement, impulse duration); this conclusion is confirmed also by the photo images of the surfaces at the test end, (fig. 9);

The images of figure 9, correlated with the maximum

depth values of the erosion from figure 6-8, show that the penetration of cavitation erosion affect in a small measure the nitrated layer remained after polishing. We appreciate that this reduced depth of the erosion is the result of the great hardness of the treated layer (550...600) HV<sub>0.3</sub>, (fig. 4).
