Bacterial Activity in a Deposit from a Residual Injection Water Pipeline

This research was conducted on a deposit sampled from a residual injection water pipeline, where corrosion problems identified on metallic equipment have been suspected to be caused by microbiological activity. The residual injection water was also analyzed to confirm the bacterial activity inside the pipeline. Microbiological activity is internationally recognized as a significant contributor to corrosion problems of oilfield equipment, being characterized by rapidity, severity and localized nature. The commonly encountered deposits in water injection pipelines include salts, corrosion products, microbiological mass, suspended matter and water. MIC mitigation methods, as biocide treatment, cannot be implemented without evaluation and confirmation of bacterial activity in the deposit. Several techniques were performed, as SEM and EDS analysis of the deposit to characterize the morphology and elemental composition and microbiological analysis and microscopic examination of the biofilm contained by the deposit, which demonstrated the presence of bacteria communities responsible for MIC.

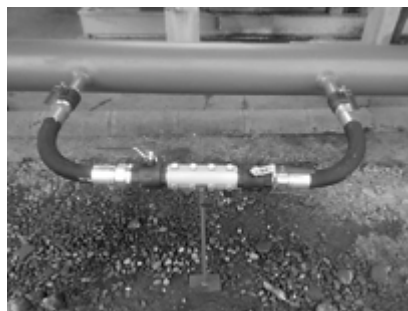
The deposit was sampled using an in-house manufactured device, which was installed as side stream of the pipeline and allowed the accumulation of deposit on metallic disk coupons. The installation point of the device is presented in figure 1.

Fig. 1 Installation point of the device

The device had removable disk coupons exposed internally, similar in composition to the pipeline, which were mounted in 12, 3, 6, and 9 o'clock positions on the circumference of the device in order to study the spatial distribution of bacterial activity. The device was exposed for a specific period of time and transported, maintaining

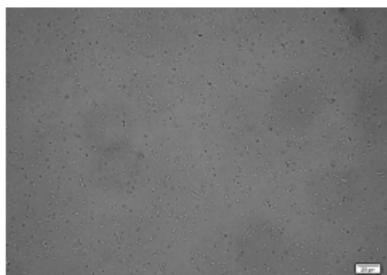
Fig. 8 Photomicrograph of SRB in biofilm sample, 400X

Specific bacteria shapes were distinguished in the biofilm (fig. 8-10). SRB, APB and Iron Oxidizing Bacteria were recognized in all biofilm samples from every position on the circumference of the device.
