Susceptibility to Stress Corrosion Cracking in Hydrogen Sulfide Environment of MAG Welded Joints of API 5L x 65M Thermomechanical Treated Steel

ION MITELEA, DINU SIMIONESCU, ILARE BORDEASU*
Polytechnica University of Timisoara, 2 Victoriei Sq., 300006, Timisoara

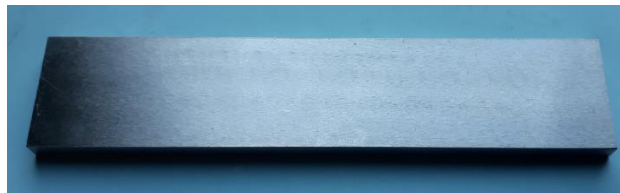
Fig.3 Aspect of specimen before deformation

The dimensions of the test specimen are shown in fig. 2, and fig. 3 shows the aspect of the specimen before the deformation.

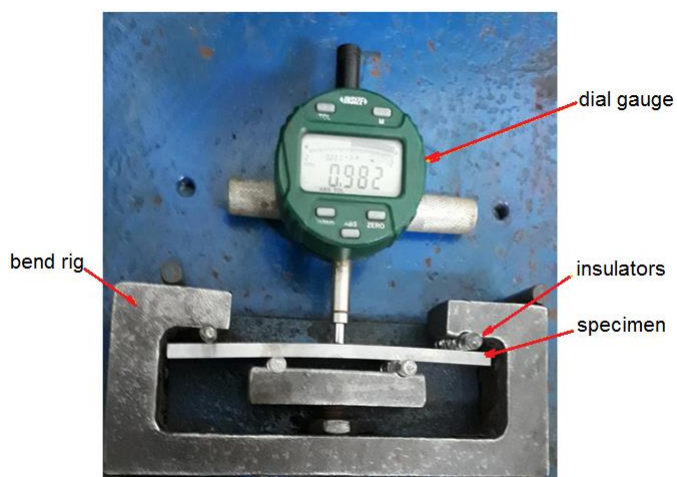
The measurement of the maximum deflection, $y = 0.982$, in the central area of the specimen was made by means of a dial indicator (fig. 6).

Fig.6 Measurement of bending specimens

After obtaining the calculated value of the maximum deflection, $y = 0.982$ mm, the inner rollers (central) are blocked so that the deflection will remain constant.

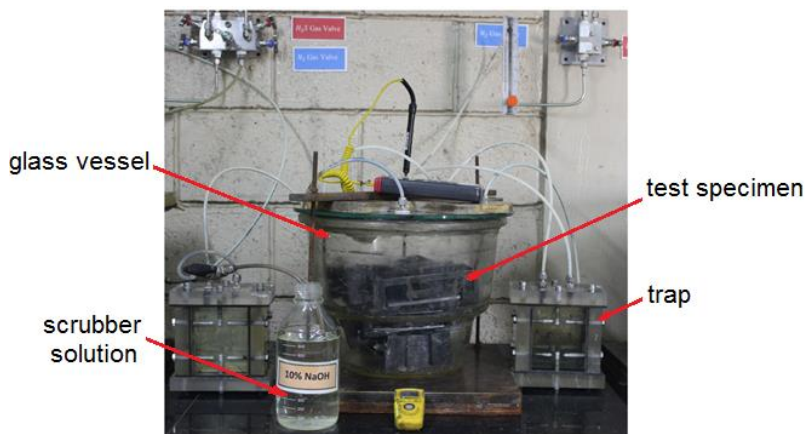
Fig. 8. Stress corrosion cracking installation

The rollers (outer and inner), made of silicone, are insulators between the test specimen and the bend rig. The schematic diagram of the test installation is shown in figure 7 and its image is shown in fig.8.

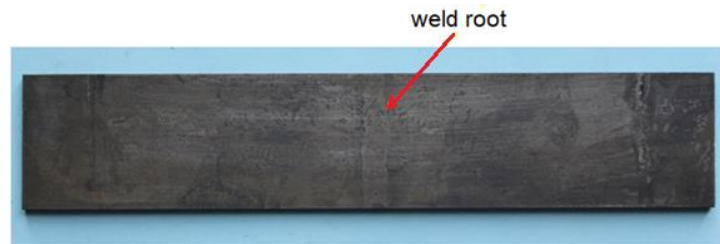
After the test, the bent specimens were removed from the glass container and cleaned with water, detergent and acetone. In Figure 9 a, b and c are shown images of specimens (root, the middle and the top) at the end of the corrosion test.

Fig.9. The appearance of the specimens at the completion of the corrosion test: a – weld root; b – weld middle; c- weld cap

The specimens subjected to stress corrosion cracking in hydrogen sulfide medium have a pH value of 3.62 with a H₂S concentration equal to 3202 ppm and no cracks were observed in the three welded joint areas.
