Influence of Chemical Corrosive Environment with H₂S on Drill Strings, Experimental Researches

Abstract: The present researches established the failure causes of the drill string, used in corrosive environments with H₂S, in an oil field, by initiating fatigue cracks from the corrosion points on the inner surface of the drill pipes, which favoured the diffusion of hydrogen, the brittleness of the material and the brittle fracture.

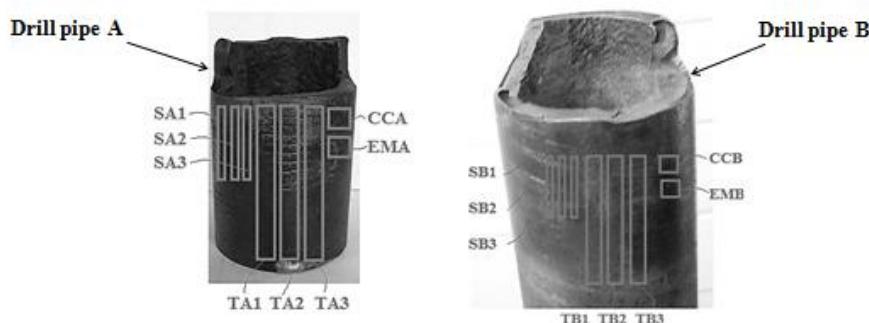
Figure 2. Samples and specimens marked for testing:
EM - samples for metallographic examination; CC - samples for chemical analysis;
T - specimens for tensile testing; S - specimens for Charpy impact testing.

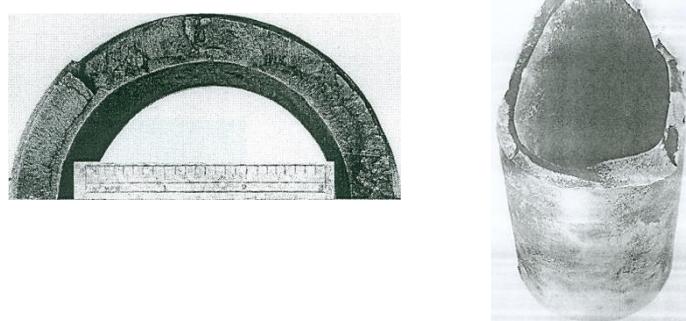
For comparison, Figure 4 shows the aspects of the fractured surfaces of two drill pipes due to the presence of hydrogen sulfide (SSC), presented in the specialized literature, [10]. In the first image presented in Figure 4, was observed an identical aspect of the fractured surface with the fractured surfaces of the analyzed drill pipes in this paper.

Figure 4. Fractured drill pipe due to the presence of hydrogen sulfide (H₂S), [8]

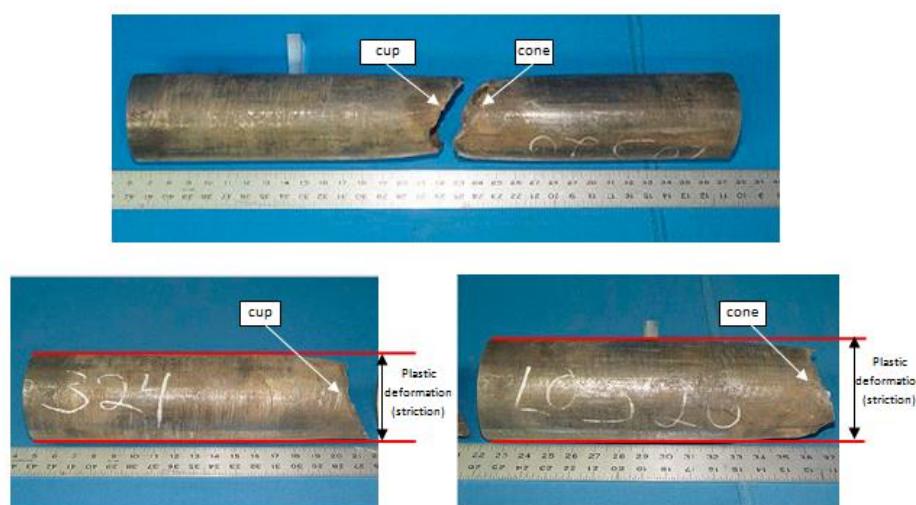
Measurement of outer diameter of the analyzed drill pipes have shown the fact that in the fractured area the diameter is constant, indicating a fracture without plastic deformation of the drill pipe, having another cause than the tensile overstress of the drill pipes. For comparison, in Figure 6 is presented, from specialized literature, the aspect of the fracture for two drill pipes subjected to tensile stress by exceeded the yield strength of the material (overload), where the plastic deformation of the fractured area is highlighted, having a specific fracture aspect cone-cup.

Figure 6. Typical aspect for fracture of the drill pipes subjected to tensile stress
