Corrosion Behavior of Welded Repairs for Water Turbine Blades

Keywords: water turbine blade, weld repair, corrosion behavior.

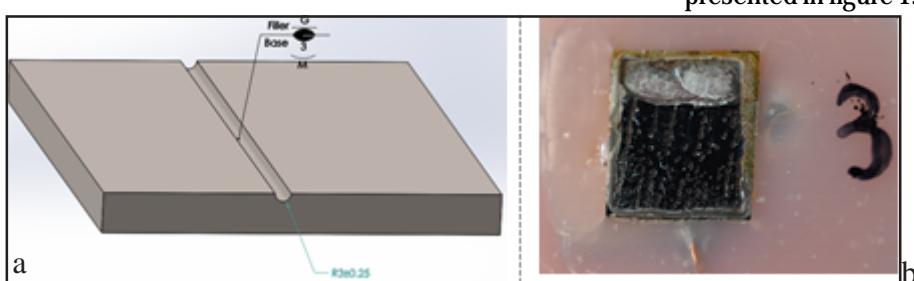
Fig. 1 Sample processing showing the a. schematic depicting machined groove for weld repair and b. mounted sample post corrosion testing

Further nine samples 600x15x15mm were obtained by cutting and milling. In eight samples a 3mm deep groove was milled to simulate erosion damage and then filled by welding using following techniques: metals inert gas welding (MIG), wolfram inert gas welding (WIG), manual metal arc welding (MMAW) and an oxyacetylene welding following a procedure similar to an in-situ repair. The filler material was chosen as 316L stainless steel. The schematic presented in figure 1.a shows the rectangular steel sample

with the 3mm deep groove milled and prepared for welding. In most internal maintenance procedures for water turbine blade repairs 3mm deep and above erosion features are mandatory for repair and weld surface finish performed by grinding.

From the large ensembles samples for corrosion testing samples were selected to include: weld material, base material and a portion of the heat affected zone (HAZ) as shown in figure 1.b, prepared according to ASTM G5 and tested using a Potentiostat/Galvanostat PARSTAT 400.

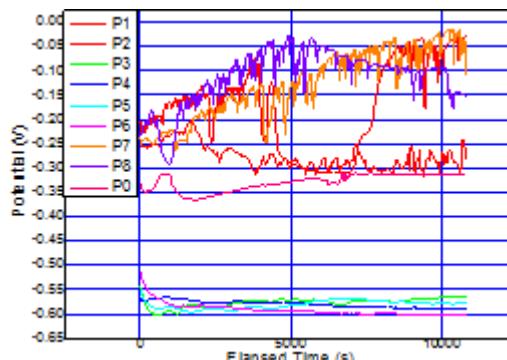
Fig. 2 Potential vs. Elapsed time curves for the tested samples

time and Current Density vs. Potential are shown in figure 2 and 3.

The fluctuations in electrode activity observable in figure 2 suggest passive film breakdown or repair and the slow potential rise followed by steep decay is the typical behavior of pitting corrosion [11, 12], as seen in figure 2.

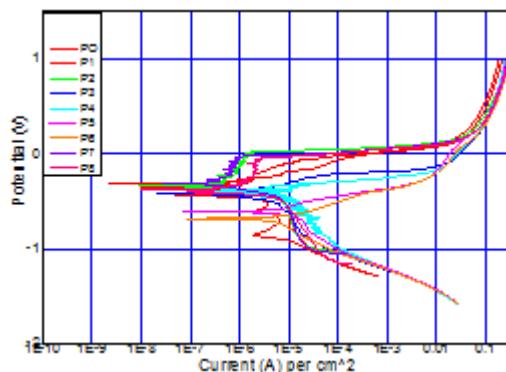
Fig. 3 Potential vs. Current density curves for the tested samples

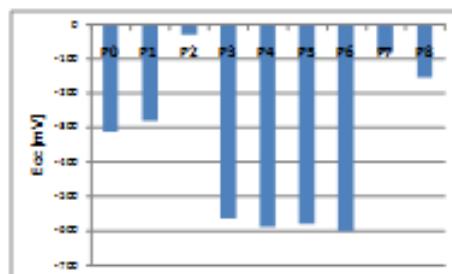
Fig. 4 Comparison of open circuit potential for tested samples

Using open circuit potential (E_{oc}) as criterion the most positive values reveal better corrosion behavior [13], in this case P2, P7, P8 and P1 exhibited the best behavior as observed according to the variation presented in figure 4.

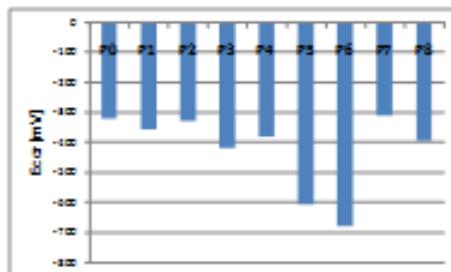
Fig. 5 Comparison of corrosion potential for tested samples.

Using the corrosion potential (E_{cor}) as criterion the more electro-positive values suggest better corrosion behavior [14], from figure 5 sample P7 would be most corrosion resistant, followed by P2, P1, P4 and P8.

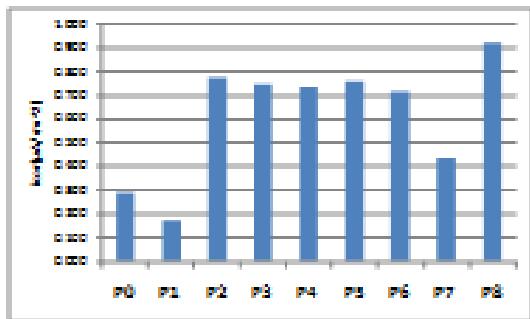
Fig. 6 Comparison of corrosion current density for tested samples.

Lower values of corrosion current density (I_{cor}) suggest good corrosion resistance [15], the variation presented in figure 6 suggests sample P1 to be best, followed by P7 and P3.

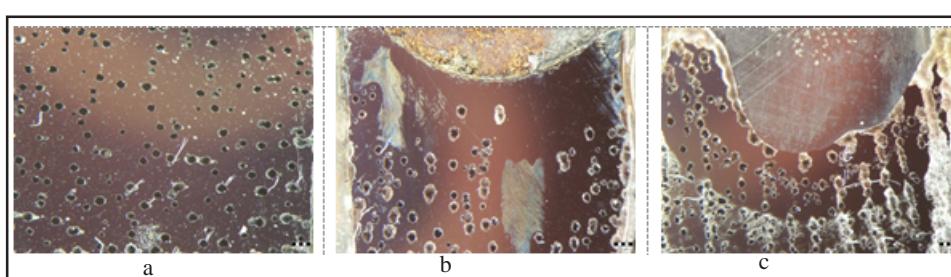
Fig. 7 Corrosion aspects on sample a. P0, b. P5 and c. P7.
Magnification: 20X

Post corrosion testing the samples are studied using the Olympus SZX7 stereo-microscope was used to study the sample surface. In figure 7 surface aspects of corroded samples are shown: figure 7a the reference sample P0, figure 7.b the sample with best corrosion resistance, P7 and figure 7c worst corrosion behavior sample P5.

Aspects of pitting corrosion can be observed in figure 7.a and 7.b, while in the case of sample P5, figure 7.c, the features tend to extend towards a generalized corrosion. An interesting feature can be observed in figure 7.c: little corrosion features appear in the heat affected zone and in sample P7, figure 7.c, the pits have a radial orientation.

By macroscopic observation alone it would be tempting to appreciate that sample P5 showed the best corrosion resistance and P7 the worst, the opposite of the corrosion tests results.

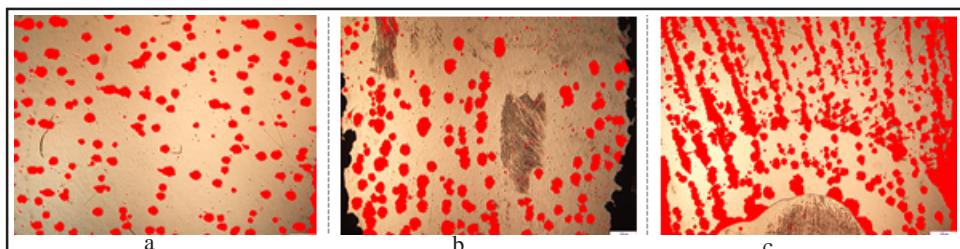
Fig. 8 Processed images for corrosion aspects on sample a. P0, b. P5 and c. P7.

Further studies on the corroded test samples implied a qualitative analysis using the area with corrosion features using the Reichert optical microscope and the dedicated software. A total of 5 fields of interest were captured and the corrosion damaged area determined, results are shown in fig. 8 using the same sample succession as presented in the stereomicroscopy studies.

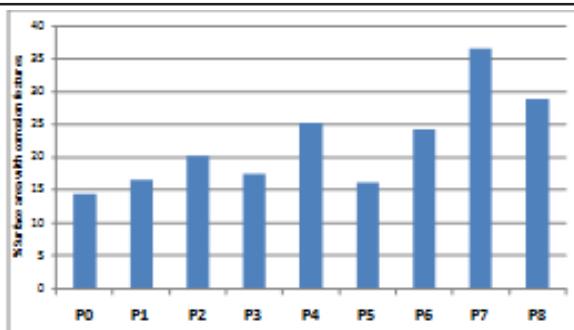
Fig. 9 Corrosion features on the investigated surfaces

For comparison a bar chart showing the percentage of corroded surface area is constructed shown in figure 9.

Using corroded surface area as criterion for corrosion resistance the worst behavior is shown by sample P7 followed by P8 and the best behavior was estimated at P5, P1, P3 and P2.

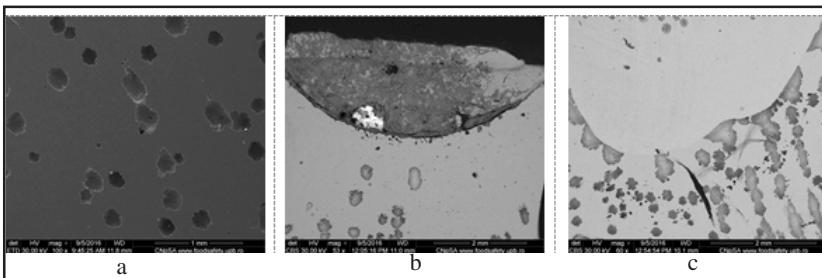
Fig. 10 Scanning electron microscopy images showing pit morphology and distribution in a. reference sample P0, b. sample P5 and c. sample P7

In the reference sample P1, figure 10a, the pits have a slightly elliptical appearance and are either shallow either deep, while sample P5 which showed worst corrosion behavior revealed shallow pits shown in figure 10b. Sample P7 showed most damage with pits distributed in a radial manner starting from the welding electrode, as seen in fig. 10c. The depth of the corrosion features was appreciated as lowest for sample P7.

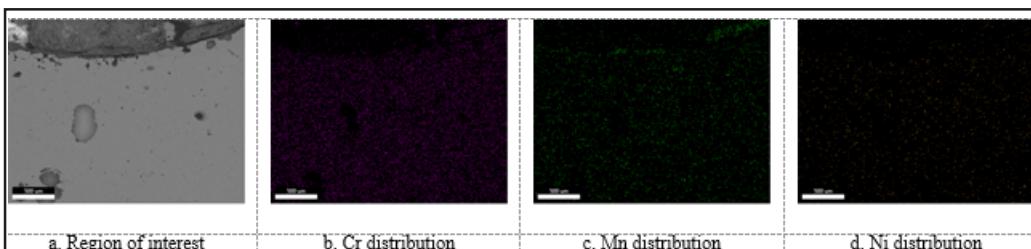
Fig. 11 Elemental distribution in sample P5

In figure 11a the region of interest is shown which comprises the weld material, heat affected zone and base material and in figure 11b to d Cr, Mn and Ni distributions.

According to the element distribution the weld material appears to be depleted in Cr and Ni or a thick oxide film was formed either during corrosion test. Regions with high Mn contents appear at the weld material - base material interface, where MnS could have formed.

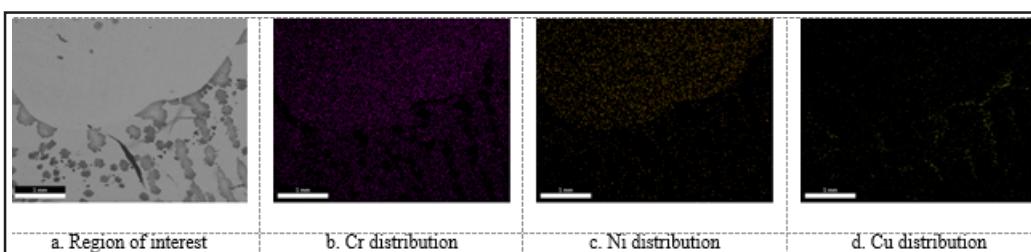
Fig. 12 Elemental distribution in sample P7

In a similar manner, in figure 12 the elemental maps obtained on sample P7 are shown for Cr, Ni and Cu.

In figure 12.b and c Cr and Ni appear in higher concentrations in the weld material, while in the base material copper rich regions are present, a segregation occurred most likely in the melted material.
